*(6) National Dam Inspection Report*  
**MARCEL LAKE DAM**

NDI - PA 00402,  
PA DER 52-149.

PHASE I INSPECTION REPORT,  
NATIONAL DAM INSPECTION PROGRAM

Name of Dam: Marcel Lake Dam                      ID # PA-00402  
State Located: Pennsylvania  
County Located: Pike  
Stream: Dingman's Creek  
Coordinates: Latitude 41° 15.2' Longitude 74° 57.4'  
Date of Inspection: November 22, 1978

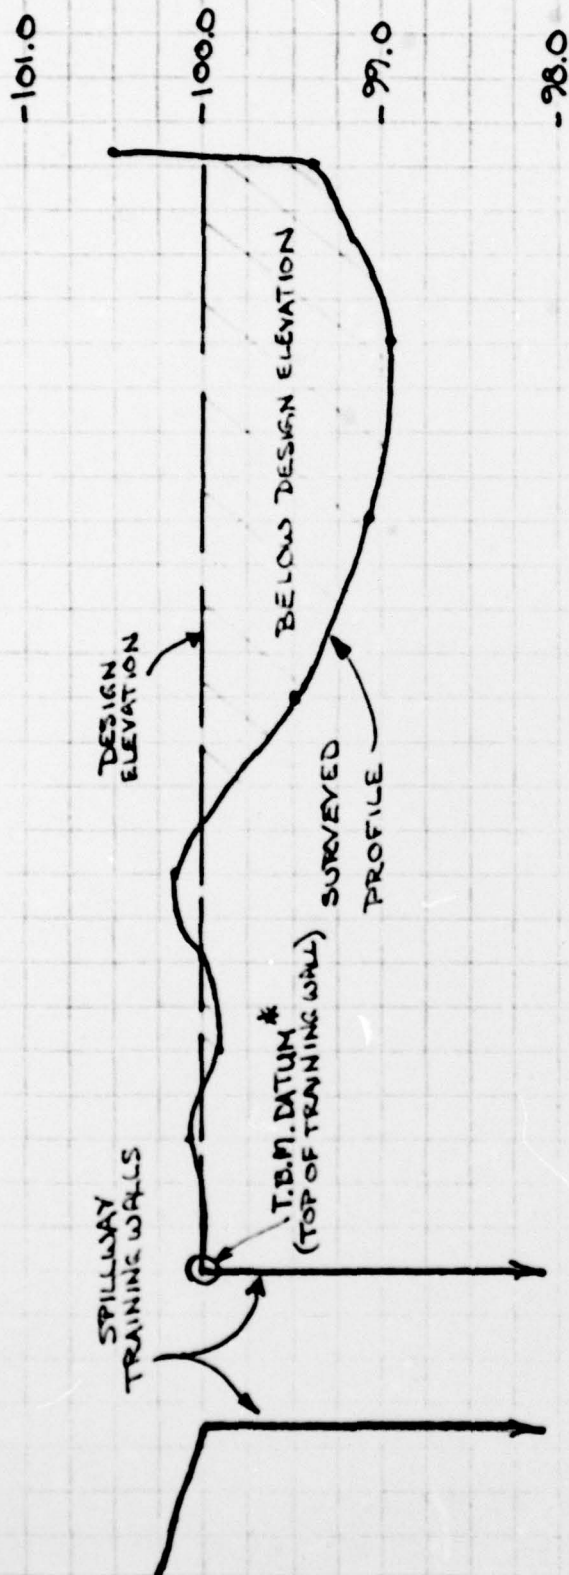
PLATE  
5

The downstream face and the top of dam are characterized by undulating surfaces, heavy grass cover, burrow holes, and occasional small trees and bushes. Review of the top of dam survey reveals that about 400 feet of the top of dam is below design elevation (See Plate 5 of Appendix E). Measurements of the slope of the downstream face revealed variations of from 1.7H:1V to 2H:1V.

The top of the dam is an undulating surface. The top of the dam survey reveals that about 400 feet of the top of the dam is below design elevation (Refer to Appendix E, Plate 5).
